**MILL POND RESERVOIR NORTH DIKE
MA 01122**

**MILL POND RESERVOIR SOUTH DIKE
MA 01123**

**PHASE I INSPECTION REPORT
NATIONAL DAM INSPECTION PROGRAM**

JANUARY 1980

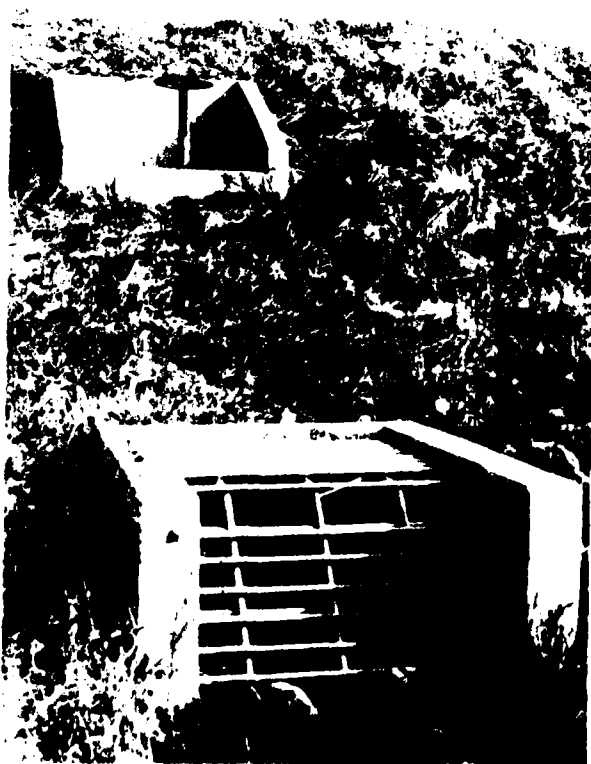
No cracks or open joints were observed in the gate valve structures or trash rack inlet structures shown in Photos 6 and 11. Some trash and debris was observed at the South Dike inlet. The concrete outlet structure on the right abutment of the North Dike was in good condition.

PHOTO NO. 6 - The inlet structure for the 24 inch drainpipe shown in this photo. It is located on the downstream side of the embankment.

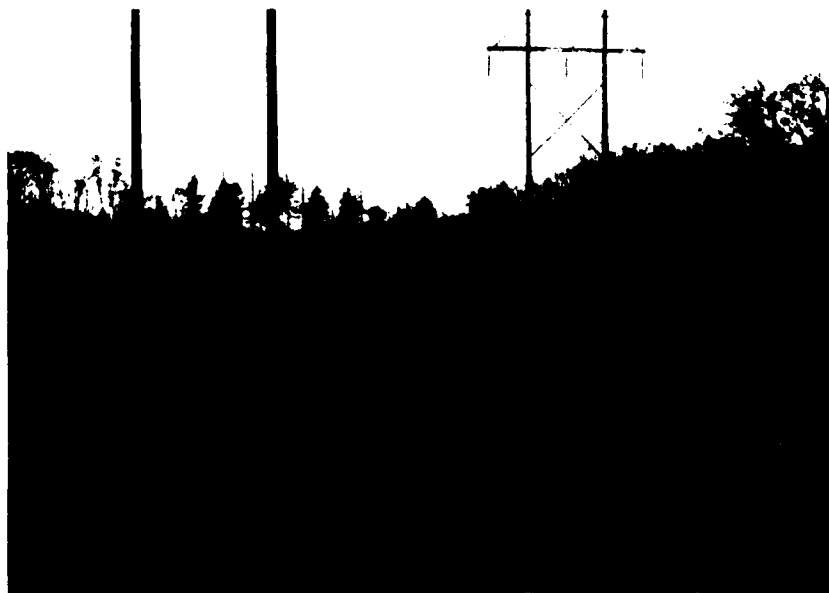
PHOTO NO. 8 - The only structures within the downstream valley are the power transmission lines. There are no residential or other structures. Development adjacent to the valley is at elev. 150+.
